Customer Notification

EW78K-xxx-EE

**Embedded Workbench[®] for 78K
Integrated Development Environment**

Operating Precautions

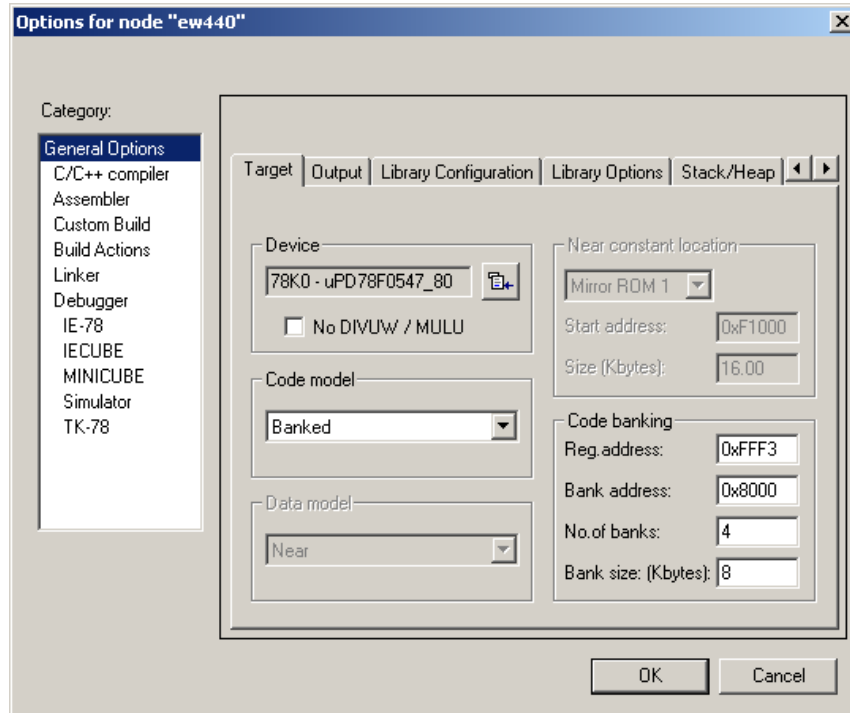
If the memory model 'Banked' or 'Standard allowing banking' is selected, the Code Banking information must be modified by the user according to the selected device, although a specific device is selected from the device list. The Embedded Workbench uses default values for the Code Banking definition independent of the selected device.

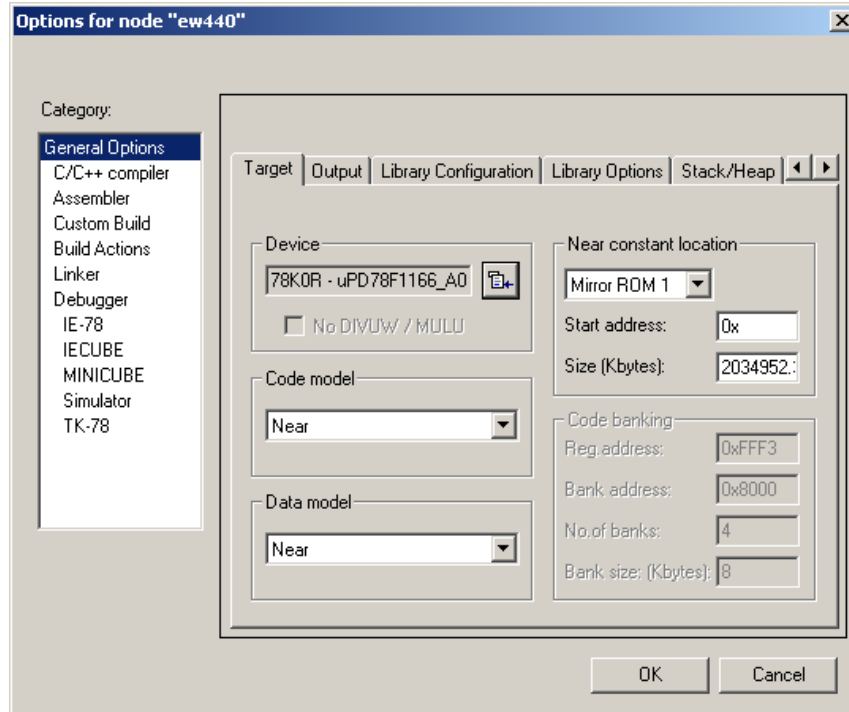
No. A9

Corrupt Default-Values for Near constant location Definition

If a specific 78K0R is selected the, default values for the Near constant location are corrupt.
Example:

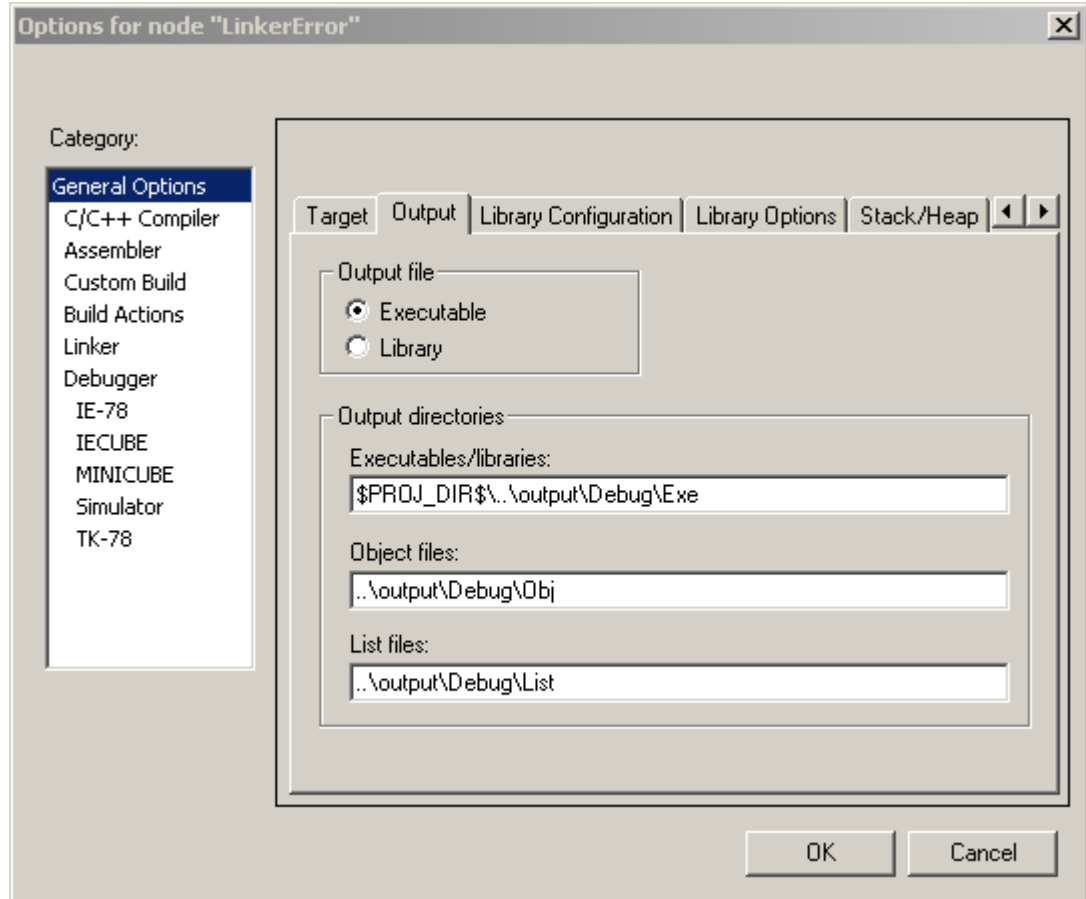
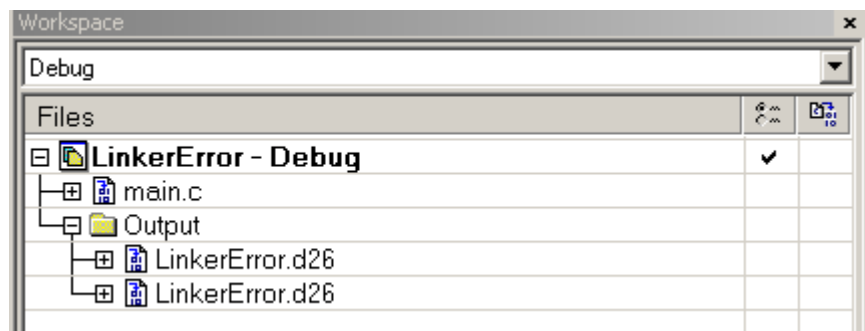
No. A10 Usage of Soft-Links in output path definition could cause the IDE to link two copies of the output files in the Workspace Windows

If the IAR System soft-links (e.g. \$PROJ_DIR\$) are used to define the output file path, the Embedded Workbench may link two copies of the generated output file in the Workspace Window.

Don't use soft-links in the output file path definition? The issue will be changed in next major update of EW78K.

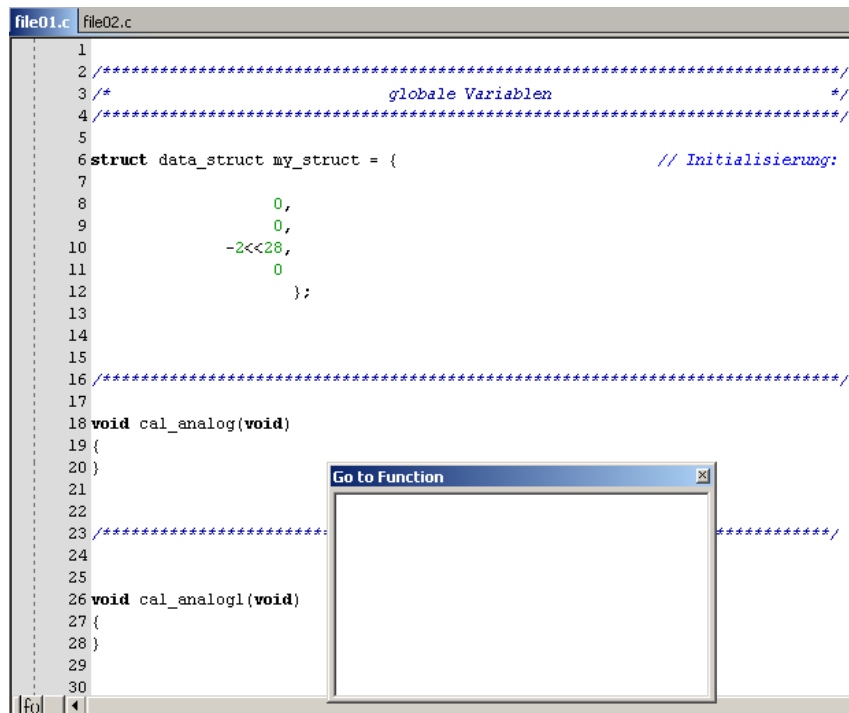
Depending on some source code constructions (e.g. using shift operator to initialize a structure element) the Go to Function Window may be empty.
 Correct Go to Function Window:

None. The problem will be fixed in the next EW78K platform update.

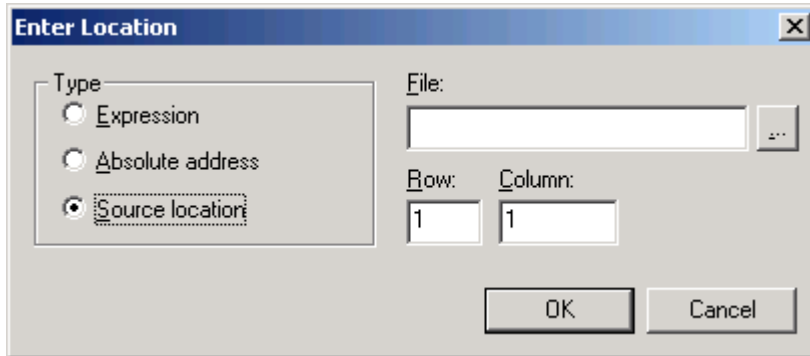
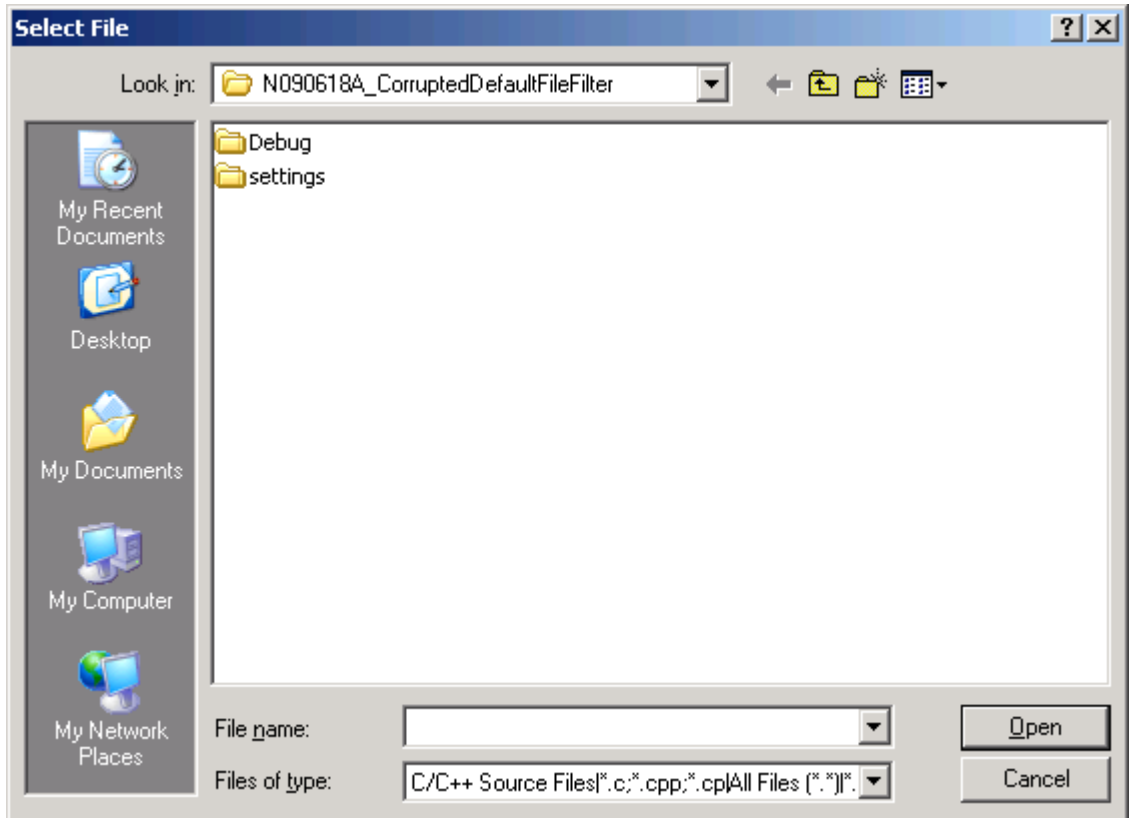
The default file filter of the C-Spy file selection dialogue after pressing the button '...' of the code breakpoint 'Enter Location Window' is corrupted and therefore no files are listed although there are source files in the selected folder:

Enter '*.*' as file name to get a list of all available source files and select the file.

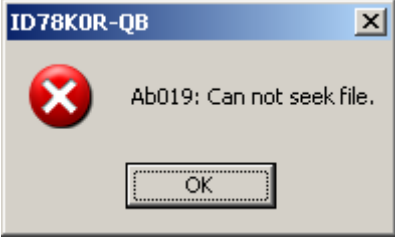
No. D23	Output file format XCOFF78K: Usage of untyped segments may cause a corrupted file
<p><u>Details</u></p> <p>If untyped segments (e.g RSEG MYDATA(1)) are used in an assembler file, the generated NEC debug file (format xcoff78) may be corrupted. The NEC debugger will generate the following error message if such file shall be downloaded:</p> <div data-bbox="708 456 1104 692" style="text-align: center;">

</div> <p><u>Workarounds</u></p> <p>Please use only typed segment:</p> <p>RSEG MYDATA(1):DATA</p>

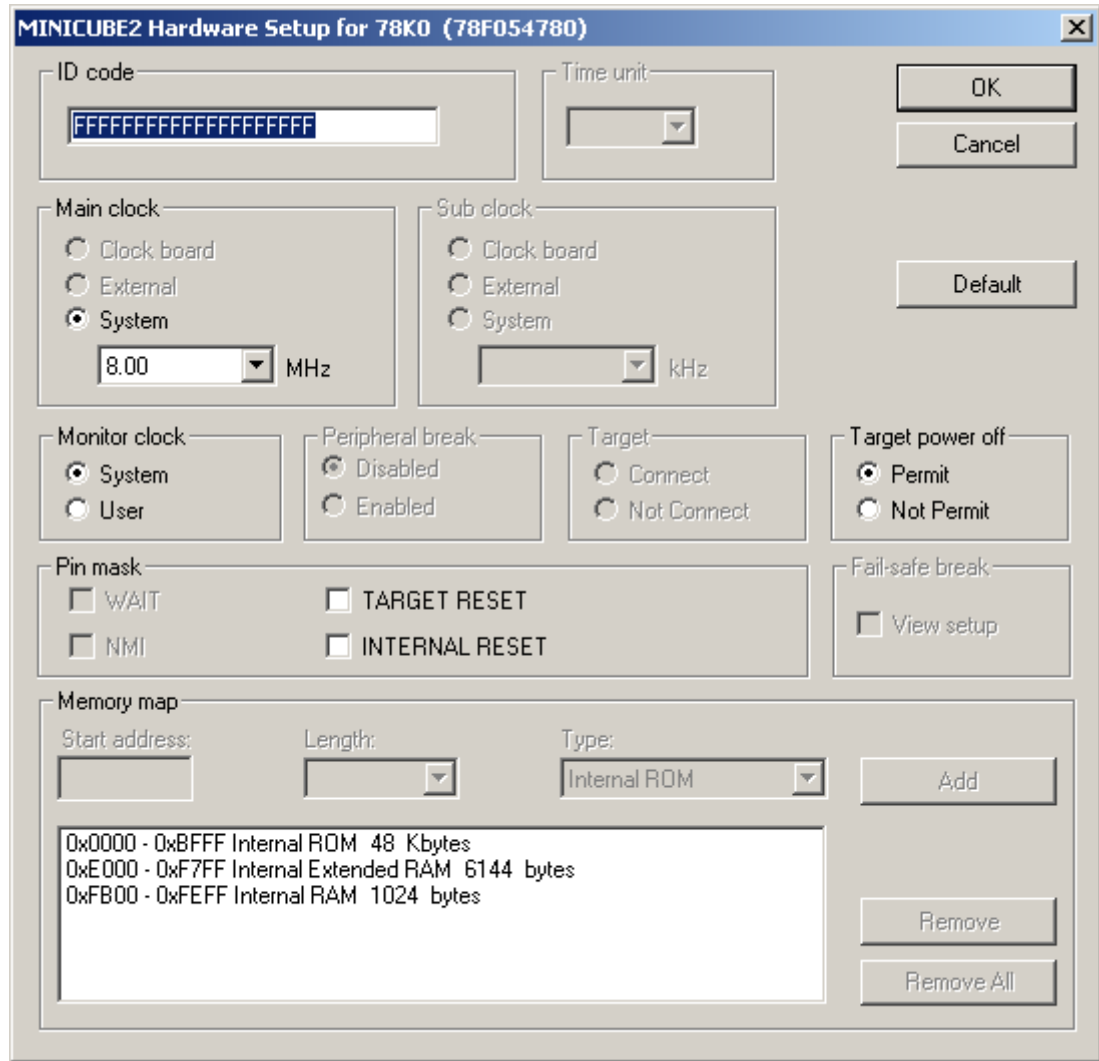
If no oscillator is mounted on the target hardware and no external oscillator is mounted on the 78K0 MINICUBE2 clock board, three different system clocks (4 MHz, 8 MHz, or 16 MHz) can be provided by MINICUBE2. The selection is done in the C-Spy Hardware Setup Dialogue:

Independent of the selection, the provided system clock is always 4 MHz.

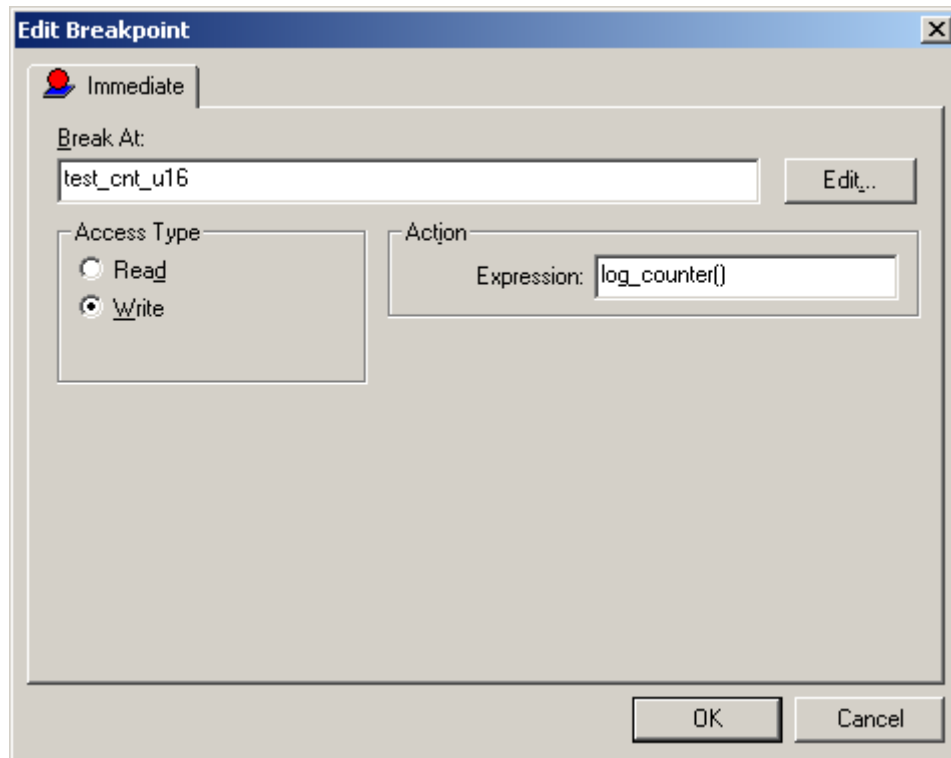
If a 16bit variable is accessed by a C-Spy macro triggered by an immediate breakpoint cause by an access to the same variable, the macro access may deliver a wrong result.

Use a software breakpoint to trigger the C-Spy macro. The problem will be fixed in the next update.

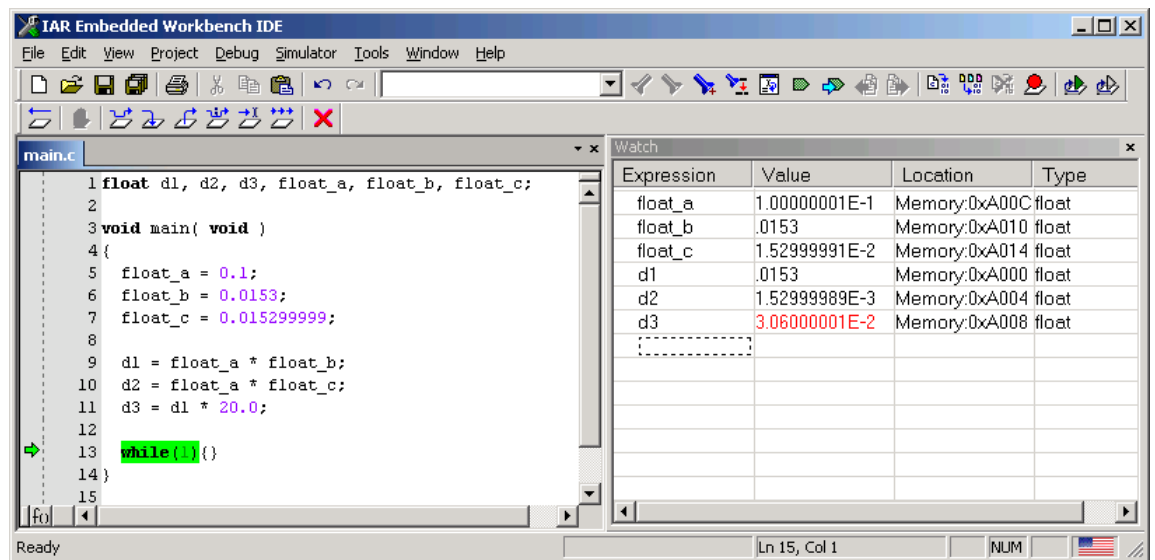
The displayed value of 'd1' is wrong, but the application uses the correct value. This can be seen in the calculated value of d3.

None. The problem will be fixed in the next update.
