Customer Notification

EW78K-xxx-EE

**Embedded Workbench[®] for 78K
Integrated Development Environment**

Operating Precautions

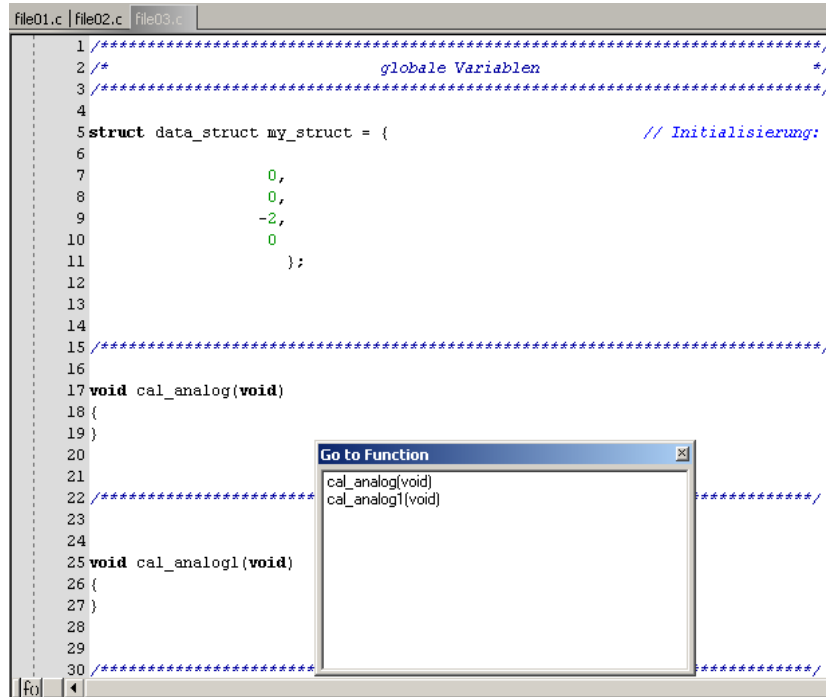
Depending on some source code constructions (e.g. using shift operator to initialize a structure element) the Go to Function Window may be empty.
 Correct Go to Function Window:

None. The problem will be fixed in the next EW78K platform update.

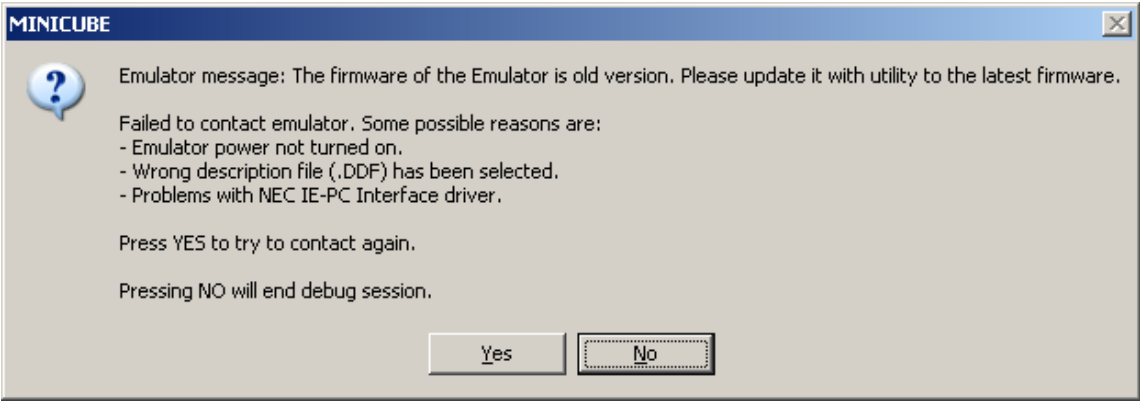
<p>No. E43</p>	<p>C-SPY 78K0R Simulator Driver: Interrupt simulation only works correct at priority level three.</p>
	<p><u>Details</u> If an interrupt level two to zero (highest) is defined, the interrupt simulation doesn't work correctly. Although the interrupt configuration (mask-flag and general interrupt enable flag) is correct, interrupts at any other level than three are disabled.</p> <p><u>Workaround</u> Please use only priority level three (lowest) until the problem will be fixed in the next version.</p>
<p>No. E44</p>	<p>C-SPY 78K0 MINICUBE2 Driver: Error message about old firmware version</p>
	<p><u>Details</u> After the installation of the update patch CS78KE_V460b the following error message will occur if the firmware-version of the MINICUBE2 is less than V4.06:</p>

<p><u>Workaround</u> The MINICUBE2 firmware V4.06 will be available b/o October 2008. Until then please contact the NEC software tool support team (software_support@eu.necel.com) to receive further information fixing the problem.</p>
